Navajo Abandoned Uranium Mine

Site Screen Report

Frank No. 2 AUM Site

Navajo AUM Northern Region

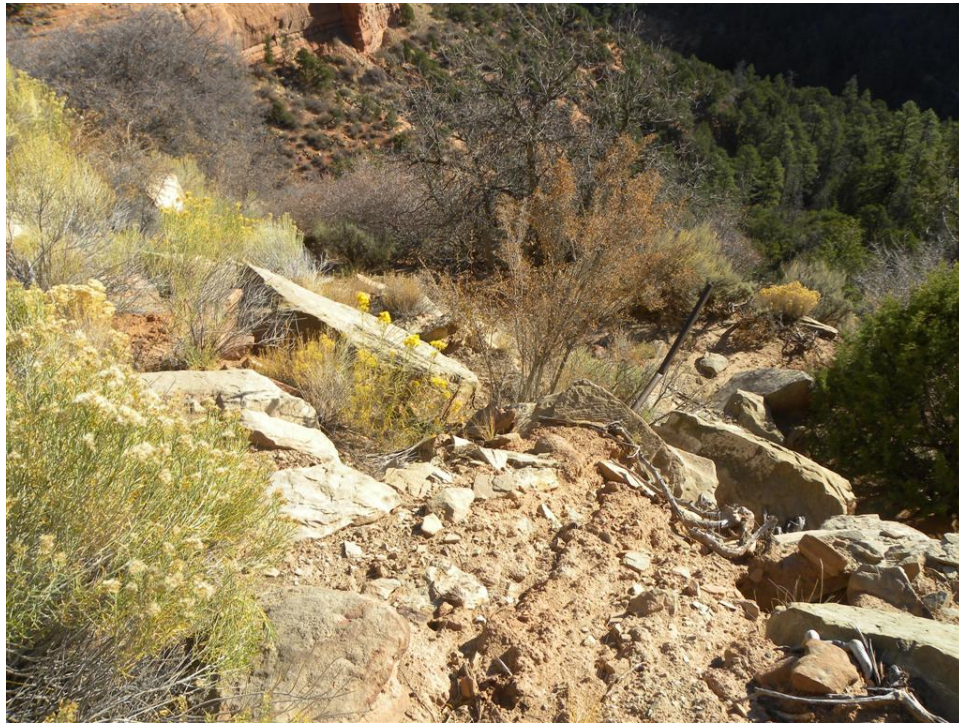
Photo 1. Down slope area

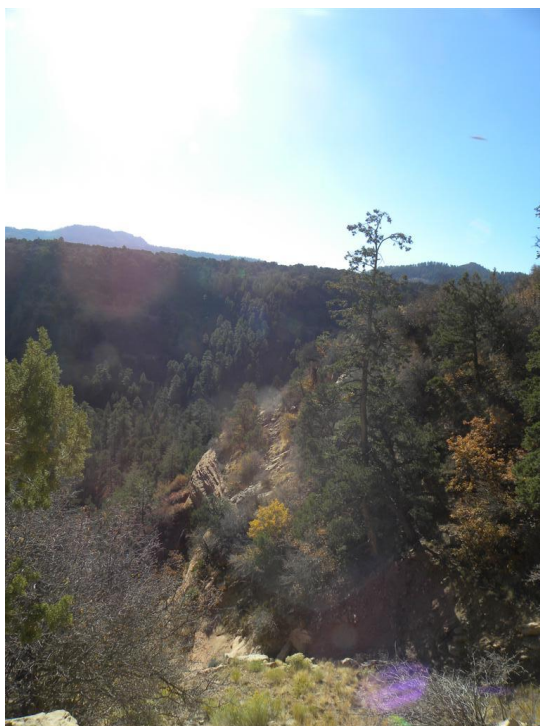
50' x 10' waste pile, with a total estimated volume of 93 yd³

Photo 3. Waste pile above

Unreclaimed waste pile
